INSTALLATION NOTICE: Outside Back Plate Assembly (416003) Excess Stud Removal

P/N 469.061 Rev. A - 16AUG01

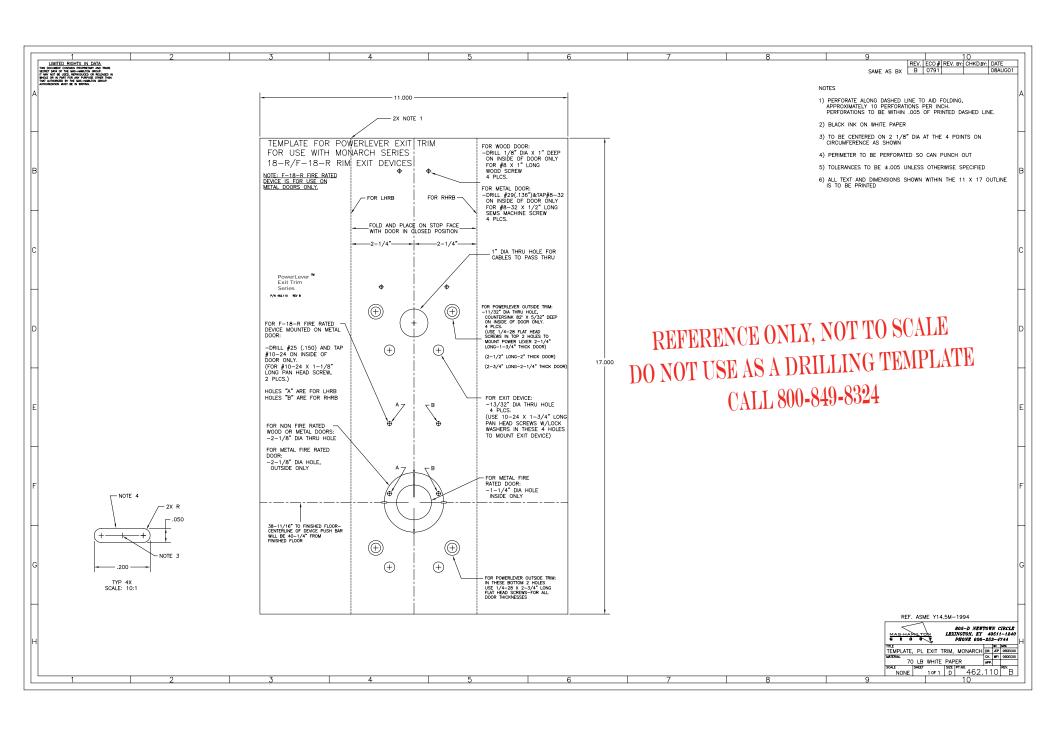
Refer to the illustration figure 5, on page 8 of the PowerLever Installation Guide:

-Attached to the PowerLever Outside Cover Assembly is the Outside Back
Plate Assembly, which has attached to it 8 internally threaded studs used to
mount the Exit Device to the PowerLever. Although 8 studs are depicted and
existing, only 6 studs are actually required for any given installation. The
purpose of using 8 studs is to accommodate either a LHRB or a RHRB
mounting scenario. All installation procedures will remain the same except as
noted in the "Special Time Saving Consideration" statement below.

The Design of the Outside Back Plate Assembly is such that it will accommodate both a RHRB and/or a LHRB installation. If elected, a shortcut is possible by removing the Back Plate Assembly from the back of the Outside Cover (held on by Qty. 3 - #6-32 screws), then knocking out the 2 studs that will not be used for the given installation. The Back Plate Assembly is then re-installed to the Outside Cover with the Qty. 3 - #6-32 screws. Use caution not to pinch the system cable or the solenoid lead wire. However, special consideration is required. Once the studs are knocked out, it will be impossible to use the Back Plate for the opposite handed installation. A hammer is required to knock out the studs which are press fitted to the plate. This will reduce the number of holes required to be drilled into the door, thus saving time.

<u>Warranty Exception</u>-Election of stud removal, as stated above, <u>will not</u> void the Mas-Hamilton Group, Inc. PowerLever Lock Series Limited Product Warranty
